# **Tree Assessment**

Prepared for Blackjack Tree Services

Town of Mahone Bay sites

October 25, 2023

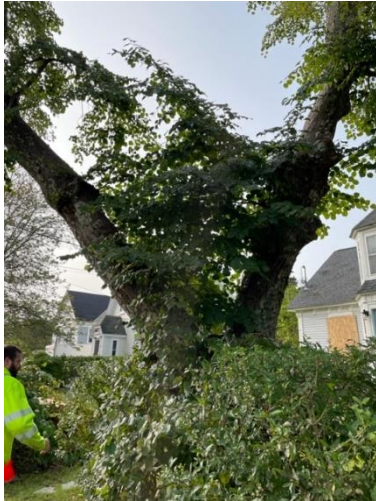
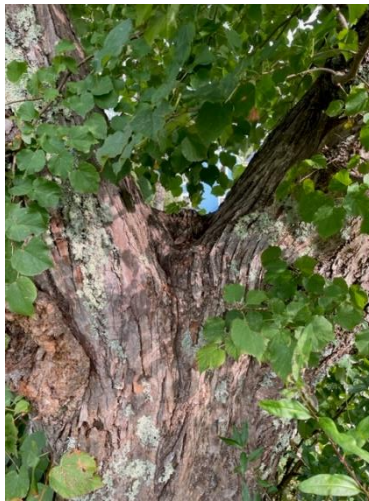
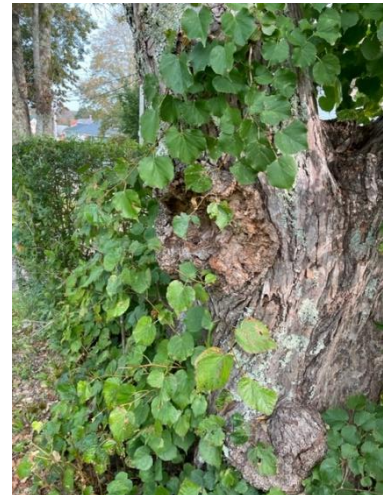
Site 1 - 68 Pleasant Street:

Elm tree. The tree is forked with two distinct stems following the fork. The fork area is under stress due to the fork being located within the first 5 to 6 feet of the tree's stem. Significant rot was observed in the stump of the tree. Neighboring elm tree was cut following windfall from a previous storm event. Sidewalk construction and street work in the past has caused damage to the rooting structure of the tree (event on neighboring tree root mass). The neighboring elm tree previously cut had rot within the lower portion of the tree still event in the stump. Assessment has determined that the entire tree be removed.

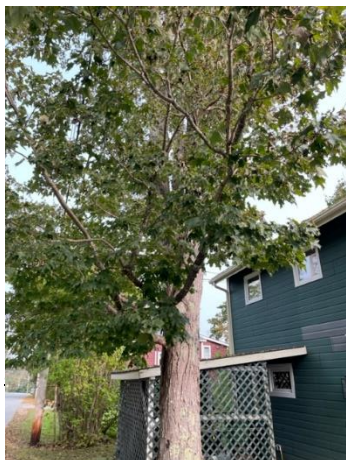
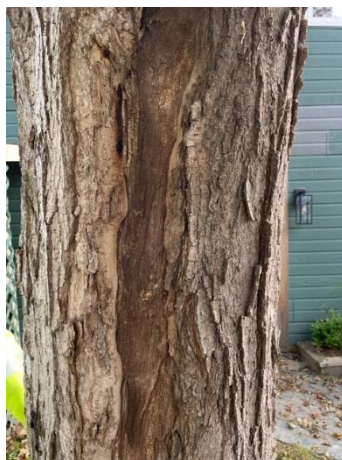
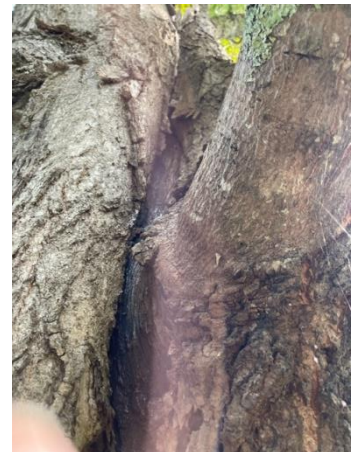
Site 2 - 65 Maple Street:

Maple tree. The tree has a large seam that travels up the stem from the base to approximately 18 feet. Within the seam there is significant rot observed. Street work in the past has likely caused damage to the rooting structure of the tree. Tree has been trimmed in the past. Assessment has determined that the entire tree be removed.

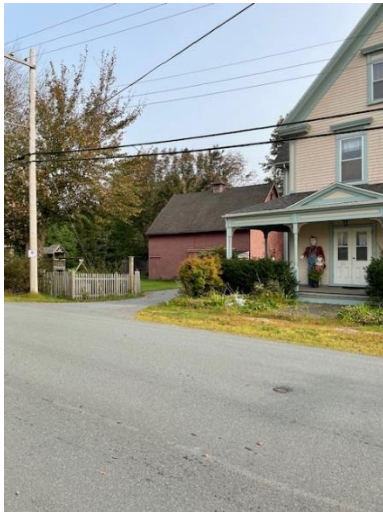
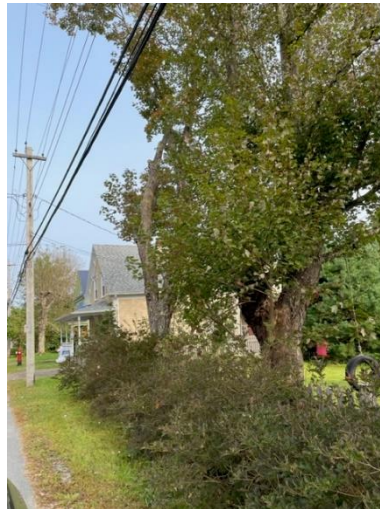
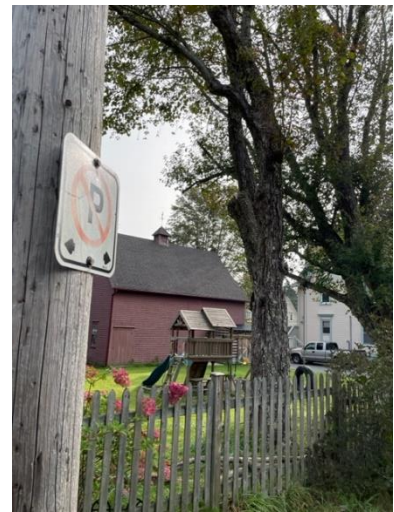
Site 3 – 77 Pleasant Street:

Three maple trees. Tree #1 (1<sup>st</sup> maple closest to house). The tree was topped previously via trimming operations. Disease and rot observed within the vicinity of the past topping operations. Assessment has determined that the entire tree be removed.

Tree #2 (2<sup>nd</sup> maple (middle)). The tree was topped previously via trimming operations. The tree at present doesn't contain significant rot or disease from previous operations. Assessment has determined that the tree can be trimmed to allow sufficient room for powerlines.

Tree #3 (3<sup>rd</sup> maple, furthest from house). The tree was topped previously via trimming operations. Disease and rot observed within the vicinity of the past topping operations. Significant fungus growth observed through the entire stem of at least two of the main stems that form the crown. Assessment has determined that the entire tree be removed.

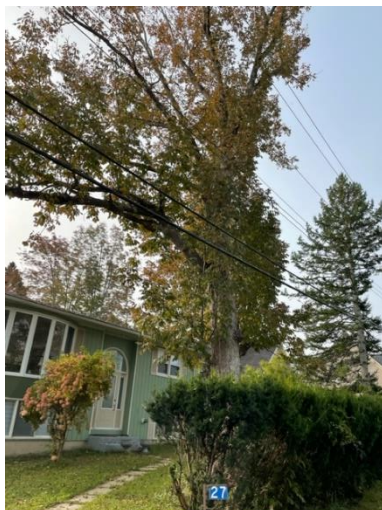
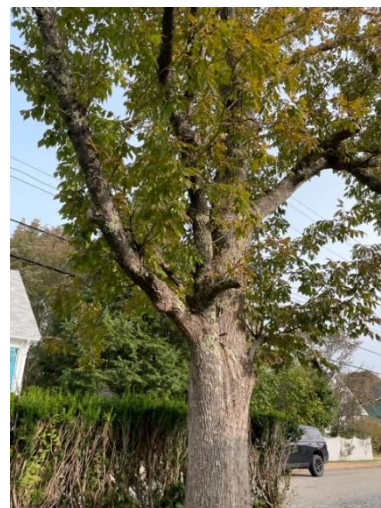
Site 4 - 27 Fairmont Street:

Ash tree. The tree has no obvious signs of rot or decay. The tree appears to be in good health with little to no structural problems at present. Assessment has determined that the tree can be trimmed to allow sufficient room for powerlines.

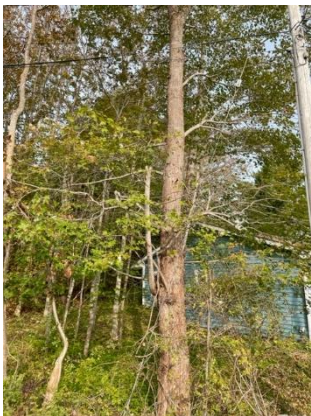
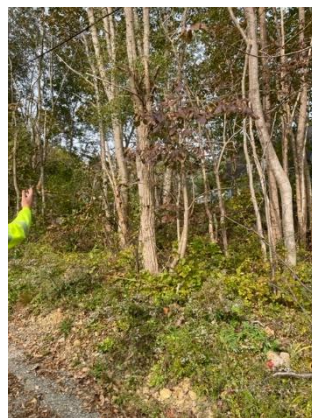
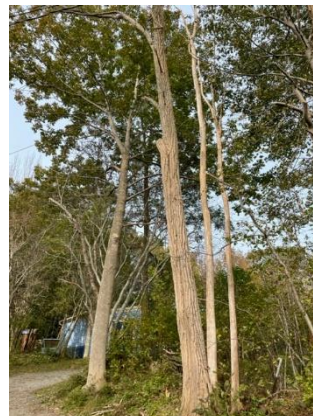
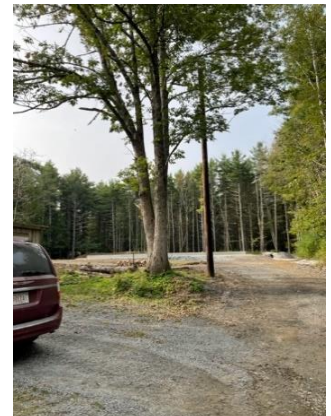
## Site 5 - Stovepipe Lane

Ash tree. The tree has no obvious signs of rot or decay. The tree appears to be in good health with little to no structural problems at present. Assessment has determined that the tree can be trimmed to allow sufficient room for powerlines.

Black Locust tree. The tree is forked near ground level. Assessment has determined that one stem from the fork (smaller stem) is impeding development of powerline and therefore should be removed while the other stem can be trimmed to facilitate powerline installation via existing poles.

Black Locust tree. The tree is leaning towards the lane and subsequently the powerlines to be installed. There are two dead stems from the base of the black locust. The tree is leaning significantly and has significant rot present at the base of the tree within the remaining live stem. Road work activity has likely caused damage to the rooting structure of the tree. Assessment has determined that the entire tree be removed.

Ash tree. The ash tree at end of lane near newly installed pole is in good shape with no significant rot or structural defects evident at present. Assessment has determined that the tree can be trimmed to allow sufficient room for powerlines.

Additionally, there is a black locus that was top cut for the powerline extension. The tree has responded by developing sprouts which are numerous and very weak therefore prone to damage and disease. Assessment has determined that the entire tree be removed.

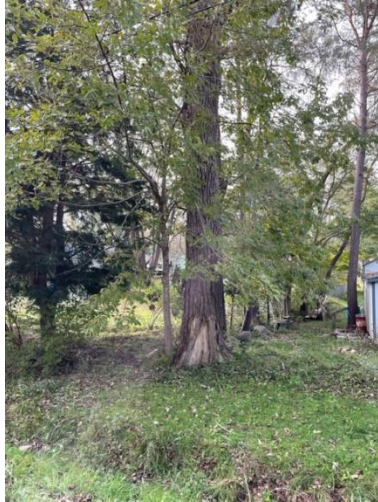
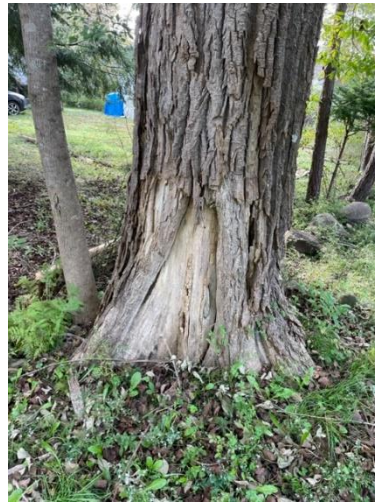
Site 6 - 18 Shady Street:

Black Locust tree. The tree has no live limbs or leaves within the upper half of tree. Only the middle portion of the tree canopy is currently exhibiting any form of vegetation growth. There is significant rot observed at the trunk of the tree. Assessment has determined that the entire tree be removed.

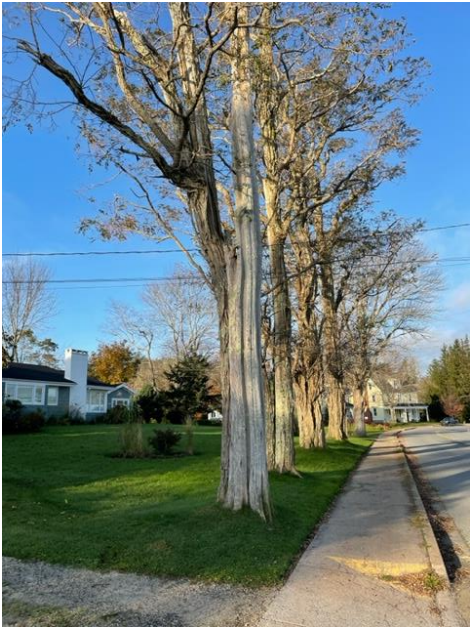
Four Black Locust trees. Tree #1 (1<sup>st</sup> locust closest to civic 712). The tree was topped previously via trimming operations. Disease and rot observed within the vicinity of the past topping operations. One significant portion of the tree is completely dead and very little live crown exists within the canopy of the tree. Assessment has determined that the entire tree be removed.

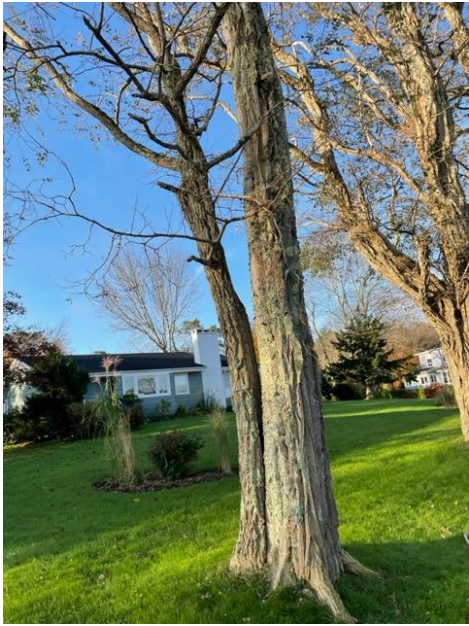
Tree #2 (2<sup>nd</sup> locust (adjacent to tree #1)). The tree received extensive trimming in the past. The tree at present has a seam traveling vertically within tree bole and rot present within seam. The tree does contain rot and disease evident from previous trimming operations. Little to no live limbs within the canopy of the tree. Assessment has determined that the entire tree be removed.

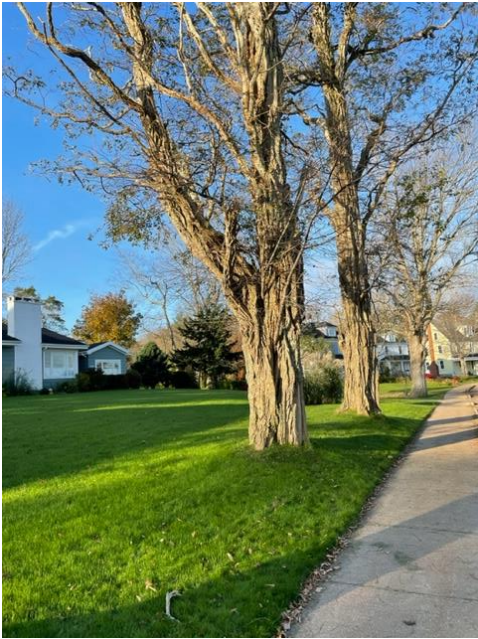
Tree #3 (3<sup>rd</sup> locust, adjacent to tree #2). The tree received extensive trimming in the past. The tree at present has a seam traveling vertically within tree bole and rot present within seam. The tree does contain rot and disease from previous trimming operations. Only a small portion of the tree canopy contains live limbs. Assessment has determined that the entire tree be removed.

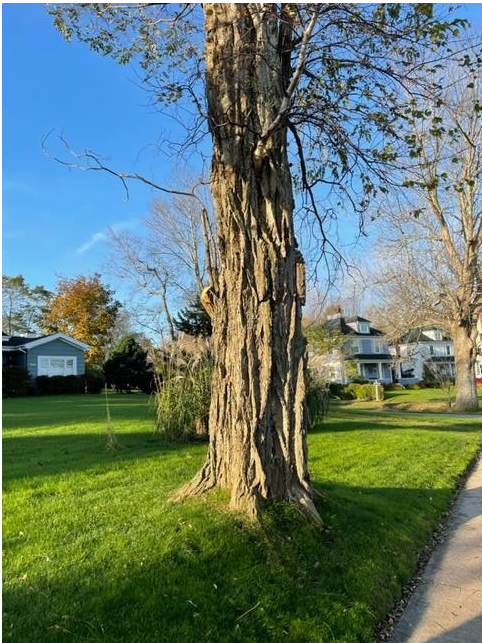
Tree #4 (3<sup>rd</sup> locust near civic 690). The tree received extensive trimming in the past. The tree at present has a seam traveling vertically within tree bole and rot present within seam. The tree does contain rot and disease from previous trimming operations. Only a small portion of the tree canopy contains live limbs. Assessment has determined that the entire tree be removed.
